# DESIGN/DEVELOPMENT REVIEW COMMISSION BAILEY BILL APPLICATION HISTORIC PROPERTY

ADDRESS: 1001 Senate Street

**NATURE OF REQUEST:** Request approval for preliminary certification for Bailey Bill and a Certificate of Design Approval for exterior changes

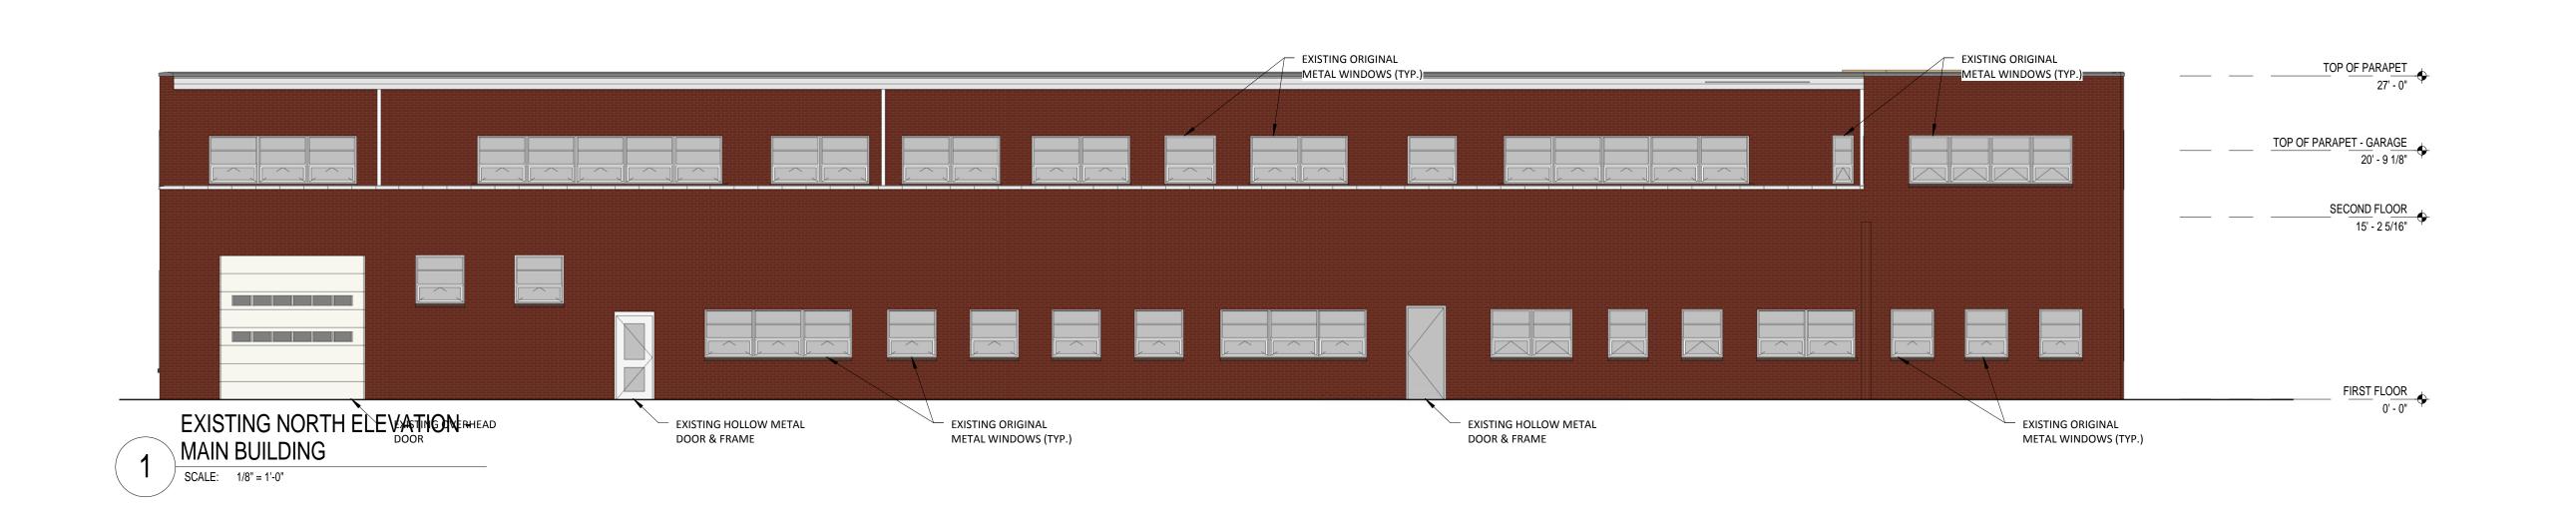
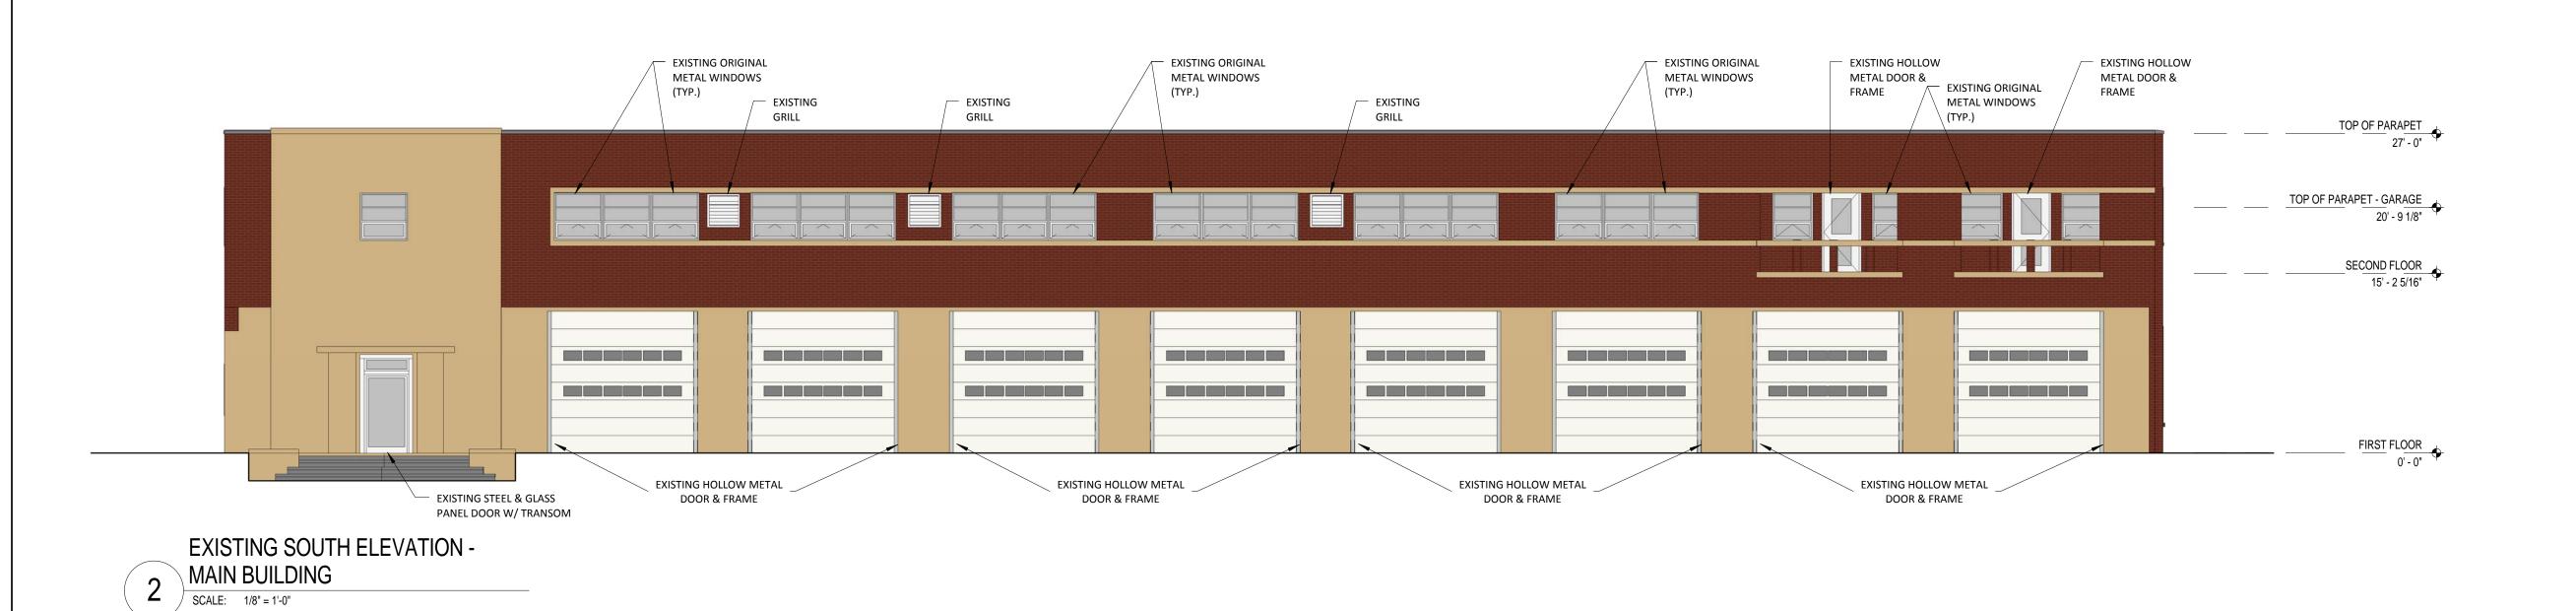
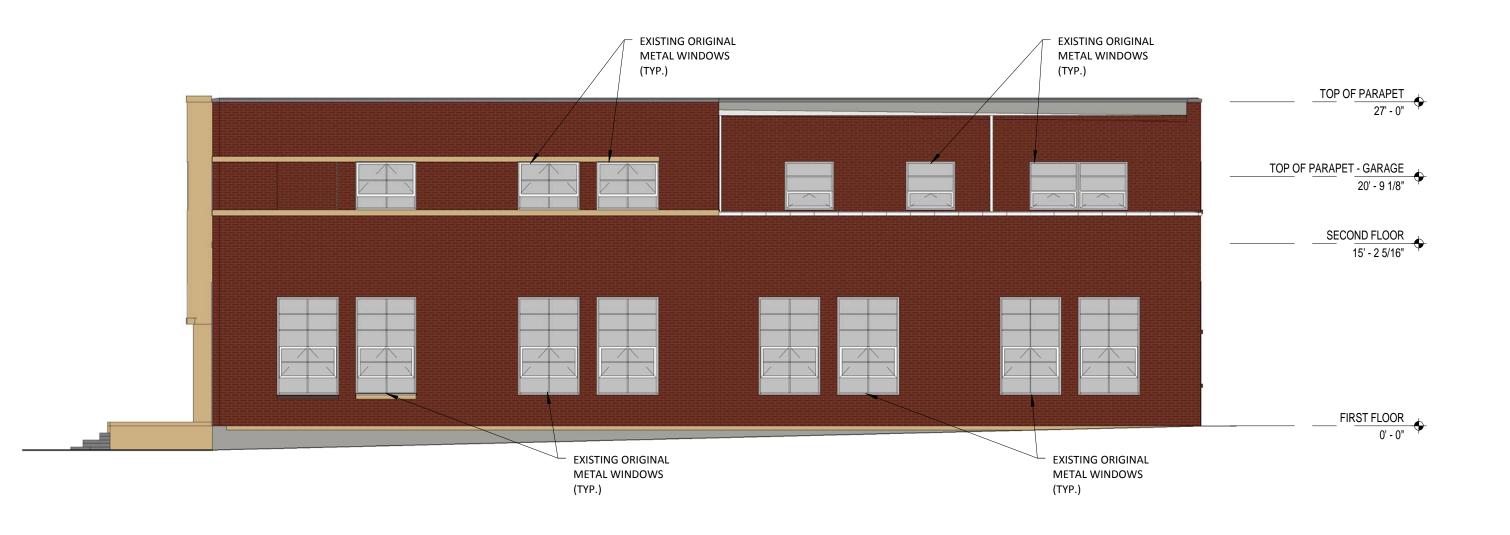
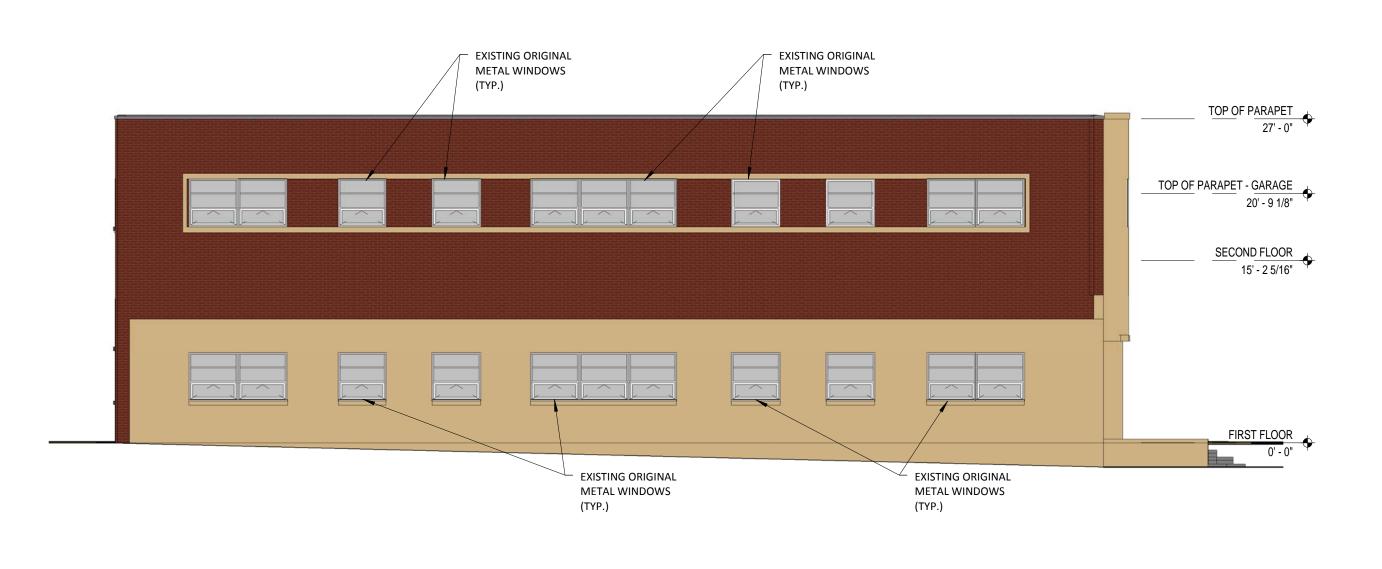
A4.1

CENTRAL EXISTING EXTERIOR ELEVATIONS - MAIN BUILDING PROJ. NO.: P230.15 DRAWN BY: Author DATE: 12.22.2015

Architectural feature Brick/Travertine Approximate date of feature 1949 Describe feature and its condition	Describe work and impact on feature  Existing brick and travertine will be cleaned per the attached masonry cleaning specs and water soak method recommended by the NPS.  Limited re-pointing with appropriate mortar will be performed as
Existing brick and travertine veneer is generally in good condition, there is some light pitting/deterioration in the travertine along the front entrance where rain water has splashed over the years. Some small areas of brick at the rear of the building contain graffiti and sections that have been painted over in the past. Vegetation has grown up some portions of masonry at the rear of the building.	necessary. Vegetation will be carefully removed. Where brick is missing or damaged beyond repair, new matching brick will replace it.
Photograph No. <u>1 - 7,17</u> Drawing No. <u>A4.1, A4.2</u>

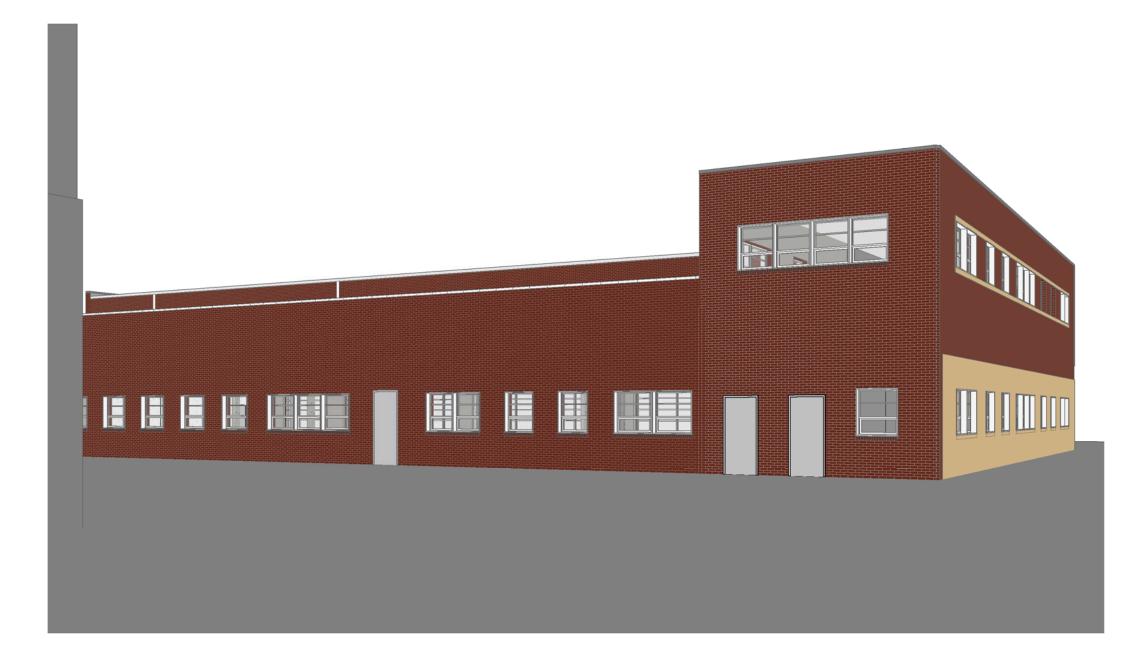
NORTHWEST CORNER LOOKING
SOUTHEAST
SCALE:

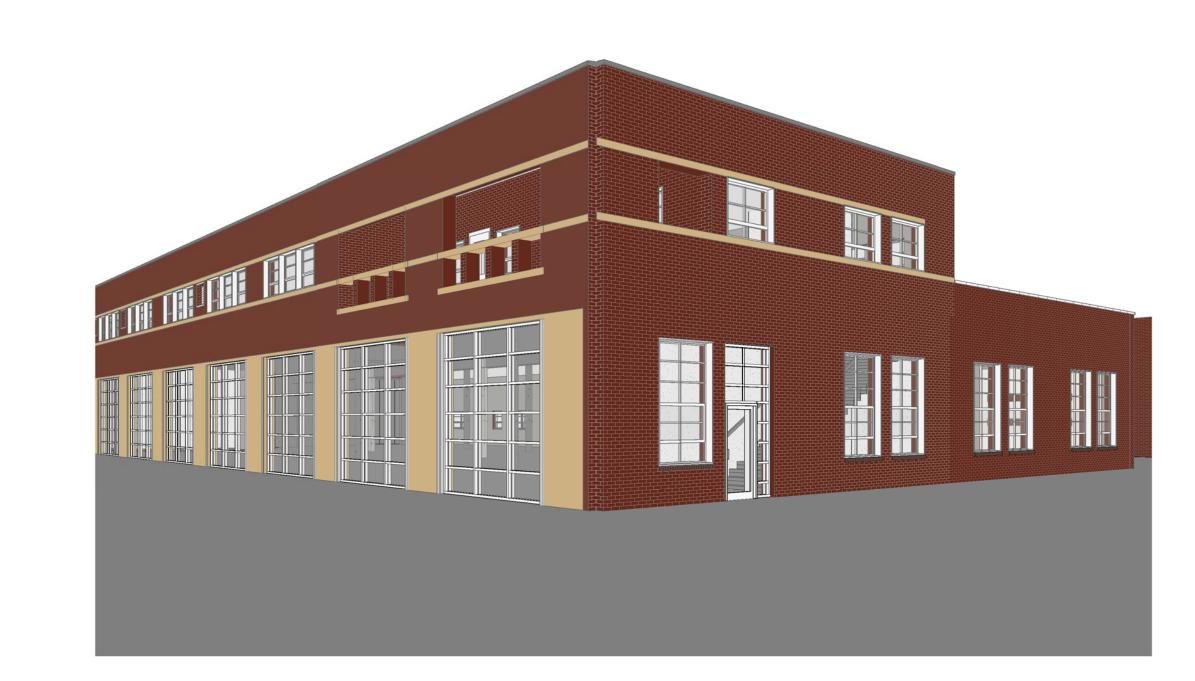
SOUTEAST CORNER LOOKING NORTHWEST SCALE:
